# Memo

**Re: TTO TC Housing, Operation 10, tool 5 XXXXX end mill  
M5 forming tap issue**

## 1. XXXXX milling tool

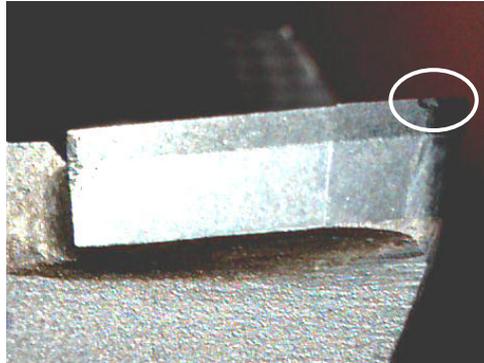
The results of observations the worn tools and machined surfaces have shown that chipping is the most common failure of the inserts brazed on cartridges. There are three areas of chipping: (a) on corners as seen in Figure 1, (b) on the flank surfaces as seen in Figure 2 and (c) on the non-working part of the cutting edge as shown in Figure 3. Moreover, the whole face of the PCD insert is covered by a thin layer of aluminum with the densest area in the center of inserts although there is should not be any contact of the chip in this area under normal cutting conditions.

**Figure 1. Chipping on the corner**

The root cause of the problem is OBVIOUS: the design and geometry of XXXXX mill cutter is not suitable for the application because the formed chip has no room to escape. The double-positive geometry used for the cartridges directs the formed chip deep into the chip pocket (the explains aluminum deposit on the insert rake faces) where this chip hits the chip deflector (explains the chip marks on the deflector). As the chip pocked is of closed design, the chip tries to squeeze into the narrow gap adjacent to the not working part of the cartridges that explains aluminum deposit on this part (see Fig. 4) and wear marks on the tool body. The hot chip trapped in the chip pocket presents a number of problems as it imposes high pressure (and deflection of the rail) on the PCD inserts causing their significant heating, vibration and re-cutting of the once formed chip.

1. Use a face mill without chip pockets (open cartridge design) as one used at YTO where consistent 15,000 pieces tool life is achieved.
2. Modify the design of XXXXX tool as follows:
  - Use standard XXXXX cartridges with a neutral top rake this should allow chips to flow out the side of the cutter and not be re-cut.
  - Tool geometry. The cutting inserts have a flat cutting edge that generates an excessive heat causing high temperature. Use the following XXXXX standard geometry for these cartridges

- Open chip pockets on the XXXXX mill to allow chip out freely, remove chip deflectors.
- Add an edge prep to the inserts which would strengthen the cutting edge.

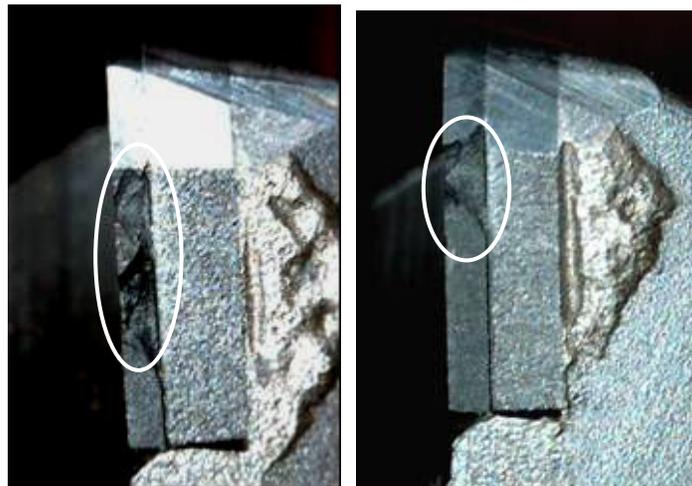
**Figure 2. Chipping of the flank surfaces**

As additional observation, we would like to prevent your attention to really poor brazing of PCD inserts seen in Figures 1-4. Moreover, in our opinion, there is insufficient flank angle (relief) on the insert that may cause chipping of the flank surfaces. Unfortunately, neither brazing, not relief angles are specified on the cartridge drawing. In our opinion, these information MUST be added to the drawing should it designed to modify XXXXX tools.

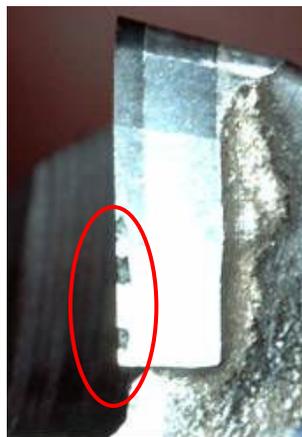
**Figure 3. Chipping of the non-working cutting edge**

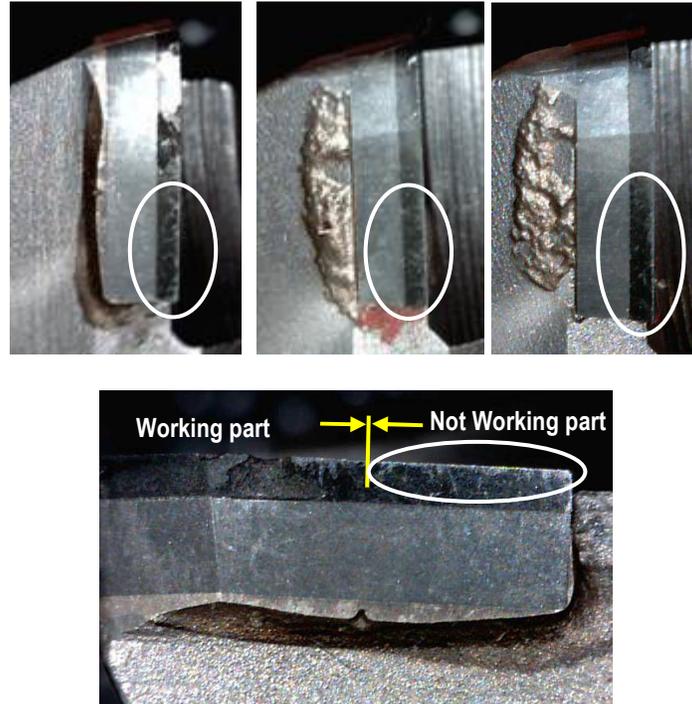
- The side edges of PCD inserts which are not involved in cutting have definite traces of aluminum as clearly seen in Figure 4.
- The chip deflators have heavy chip contact marks.

**Figure 4. Aluminum deposit on not working parts of the cutting edge**

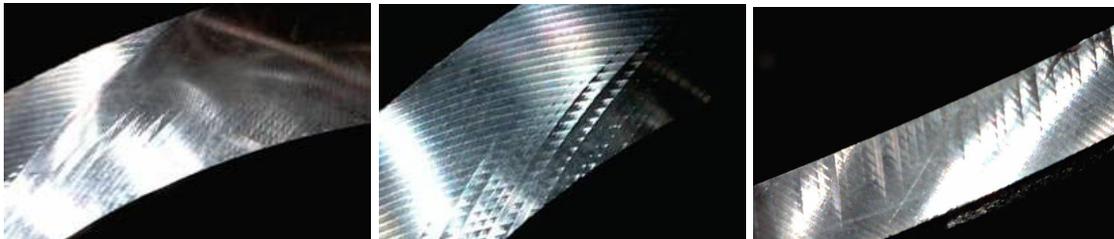
Microscopic observations of the machined surface clearly show (Figure 5) the traces of re-cutting and rail deflections on milling that confirms the root cause.

**Figure 5. Traces of re-cutting and rail deflection**
