Tooling Research and Application Department
Dr. Viktor P. Astakhov

Part and Feature: [REDACTED]

Tool: Two-flute carbide drill [REDACTED]

Problem: Hole runout

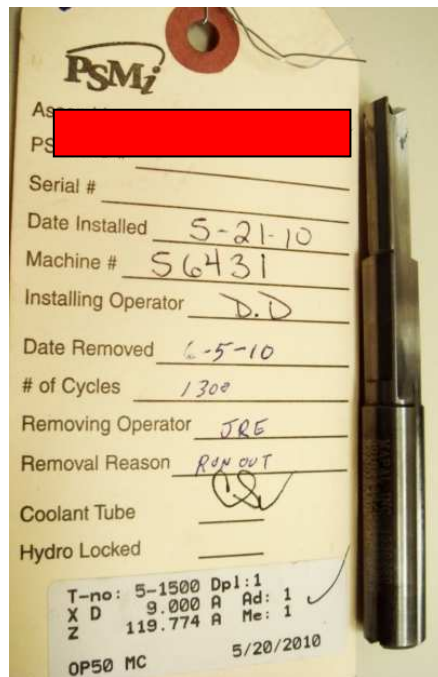
Figure 1 shows the failed tool and its tool tag. The tool is new. As can be seen, the tool ran 1,300 cycles. The tool life set for this tool is 1,500 cycles, i.e., the tool almost made the tool life. Further investigation shows that if the tool is used for standard D or C variants, it drills 15 holes per cycle, for B – 6 holes, if for DuraMax – 19 holes per cycle although the tool life is set the same for all variants. Moreover, it is a tap drill, i.e., it directly affects the performance (tool life included) of the tap that follows.

Figure 1. Failed tool and its tool tag

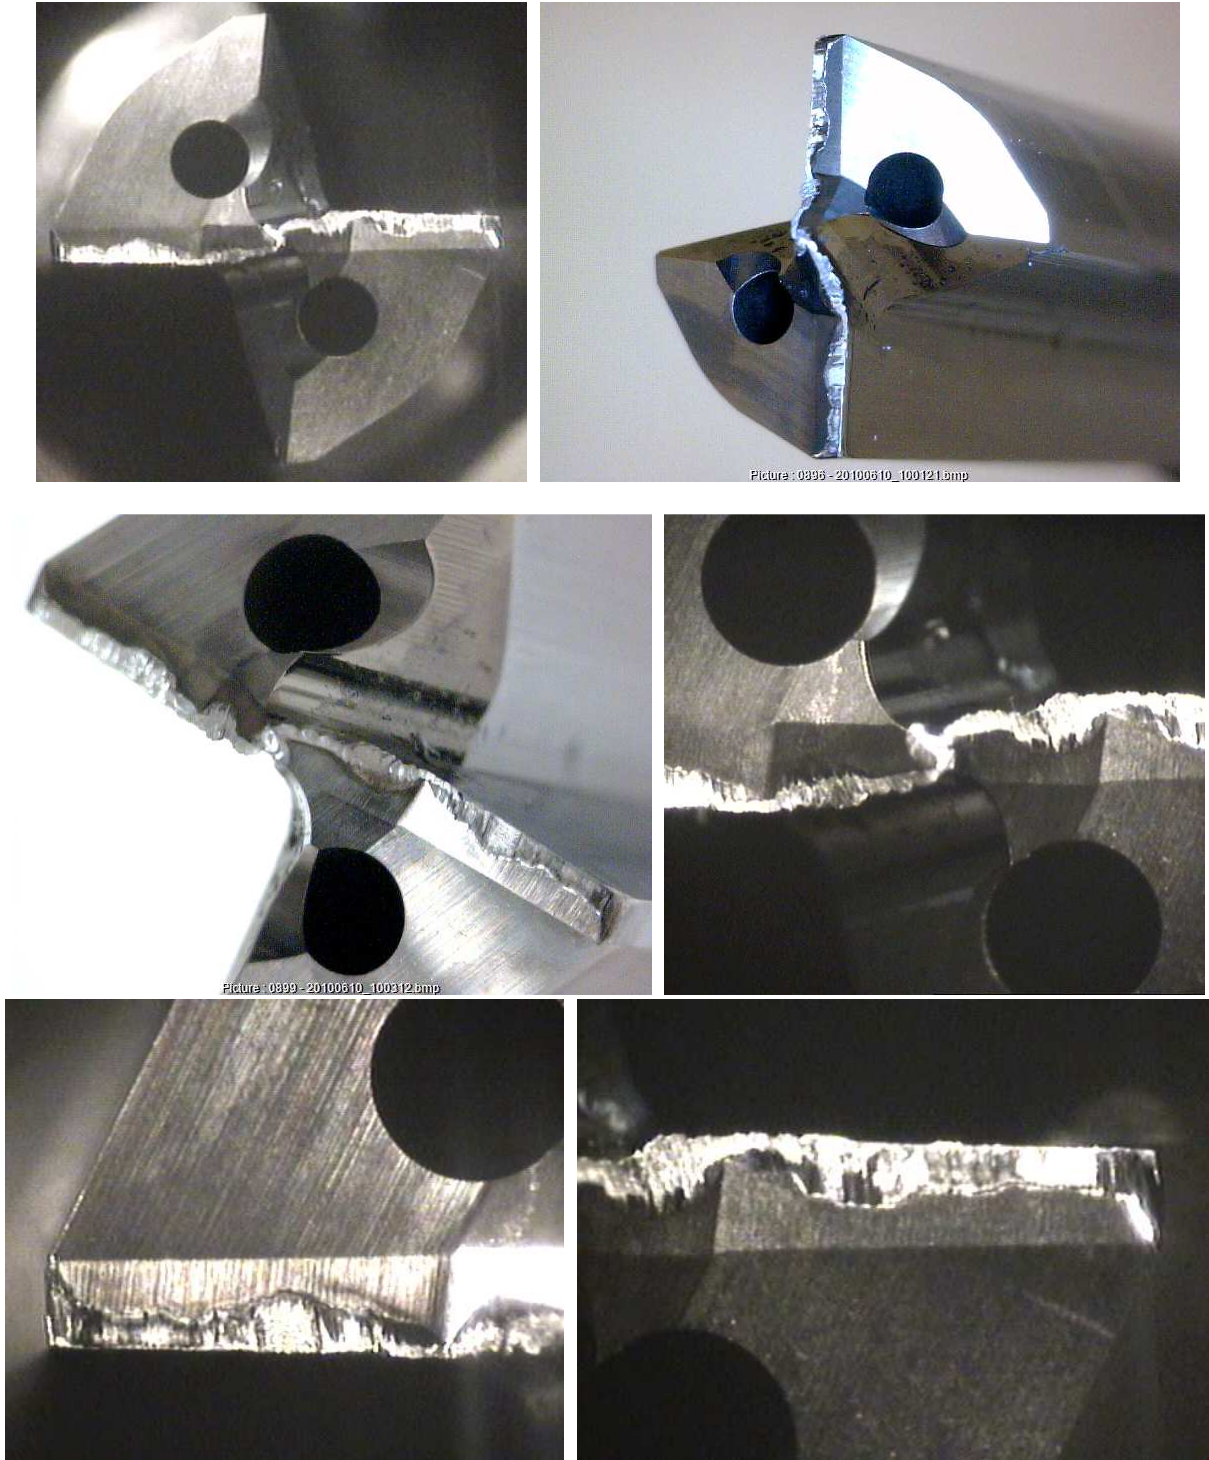
Figure 2 shows excessive wear of the drilling part of the tool. In my opinion, the tool with this amount of wear is not capable of producing decent tap holes. As a result, the tap that follows this tool will definitely suffer, and thus may produce “tight” threaded holes or may even break. In other words, the tool is a way overrun.

Figure 2. Excessive wear of the tool drilling part

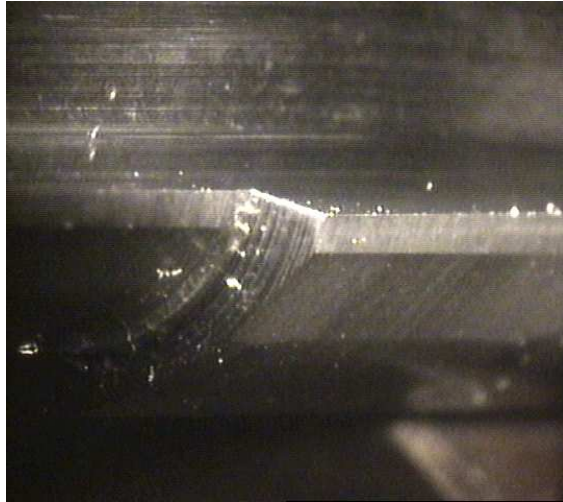
Figure 3 shows the chamfering part of the tool. As see, very small wear is seen there.

Figure 3. Small wear of the chamfering part

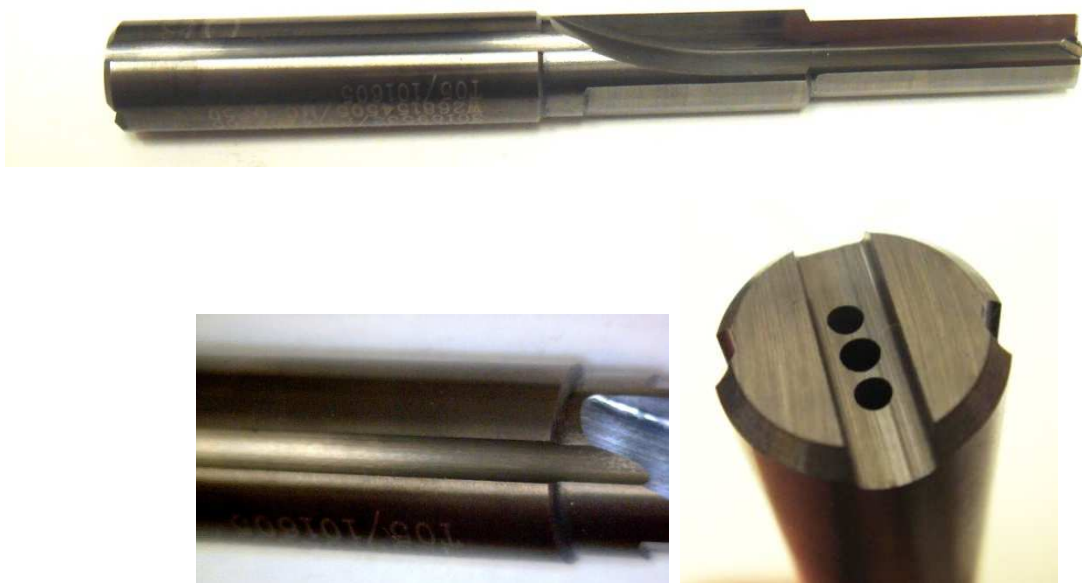
Executive summary of the analysis: The direct root cause of tool failure is an excessive tool wear caused by dry machining as the coolant did not reach the drilling part of the tool. This is because two slots-coolant passages were made on the tool shank that attracted all the coolant available in the tool holder. As this problem is common and extends even to XX-X program, it should be resolved with XXXXX as soon as possible.

Figure 4 shows the cause for the difference in tool wear of the drilling and chamfering parts of the tool. Addressing the complaint about the burr produced by the dulled chamfering cutting edges, XXXXX made two deep slots on the tool shank to introduce the coolant to these edges. As the hydraulic resistance of these slots is a way smaller than the regular coolant channel of the drilling part, almost all the coolant goes to the chamfering part of the tool while the drilling part runs almost dry. In other words, one minor problem is solved while another major problem was introduced by adding these two slots on the tool shank.

Figure 4. Slots-coolant passages made on the shank to provide the coolant to the chamfering part of the tool

1. NEVER use coolant slots on the shank
2. Re-design drill for this application. It should be standard (not brad as it is now) point PCD drill
