**Tooling Research and Application Department**  
**Dr. Viktor P. Astakhov**

**Part and Feature:** Threading tap by XXXXXXXX

**Problem:** Broken tool.

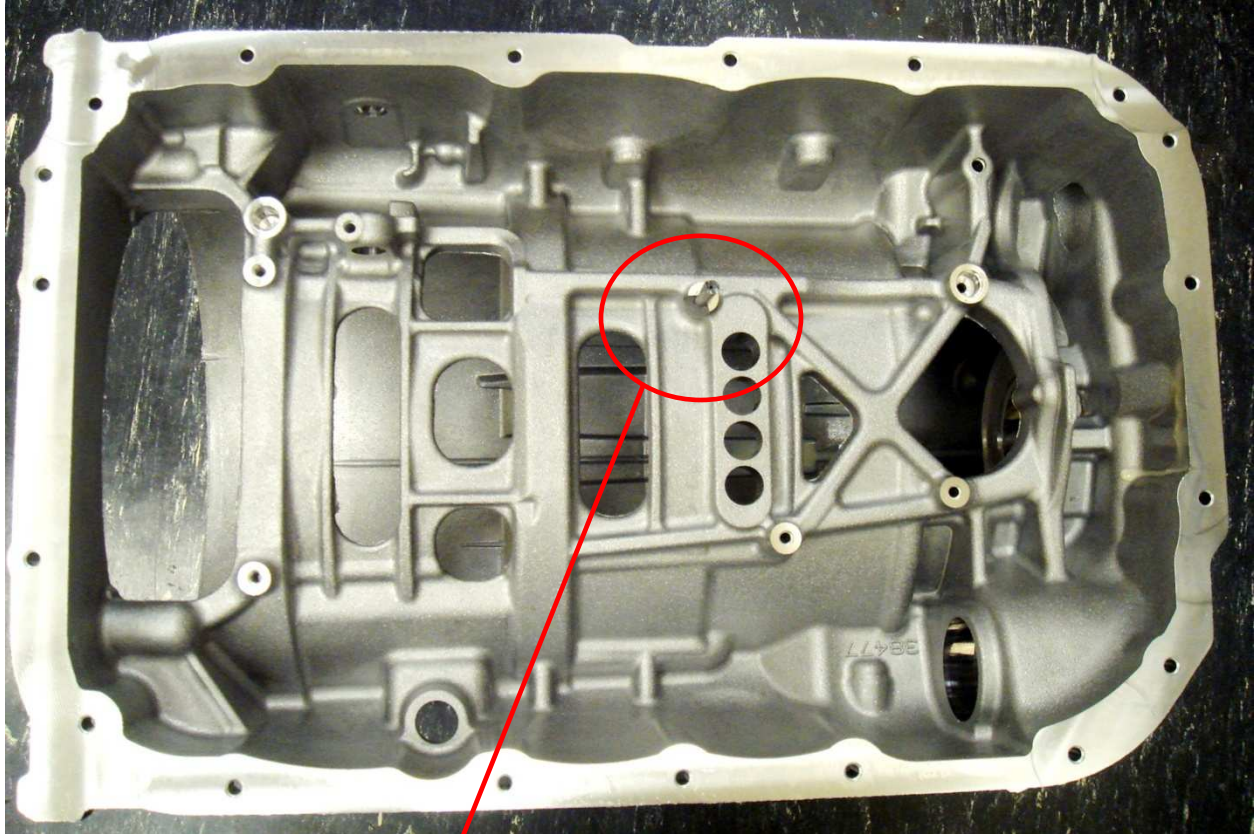
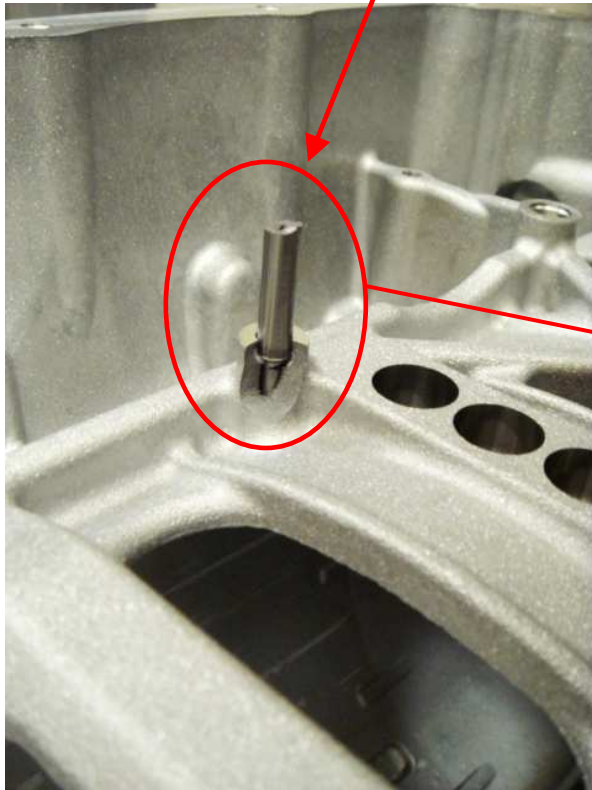
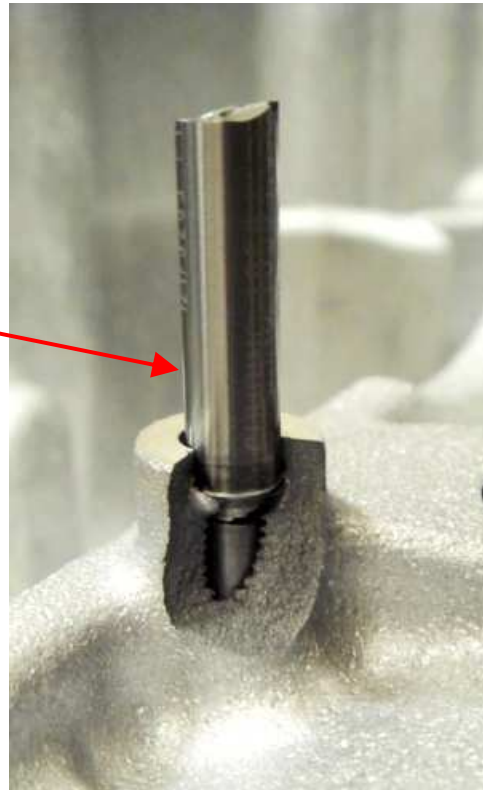
Figure 1 shows the failed tap that stuck in the case. As clearly seen, the shank of the broken tap interferes with the hole being tapped. This interference caused tap breakage. Analysis of the tap drawing (Figure 2) shows that the neck length (the distance from the end of the tap to the shank) should be 36mm. Moreover, one of the production notes on the drawing states **“Extend neck length per print.”**

**Figure 1.** Broken tab in the MC

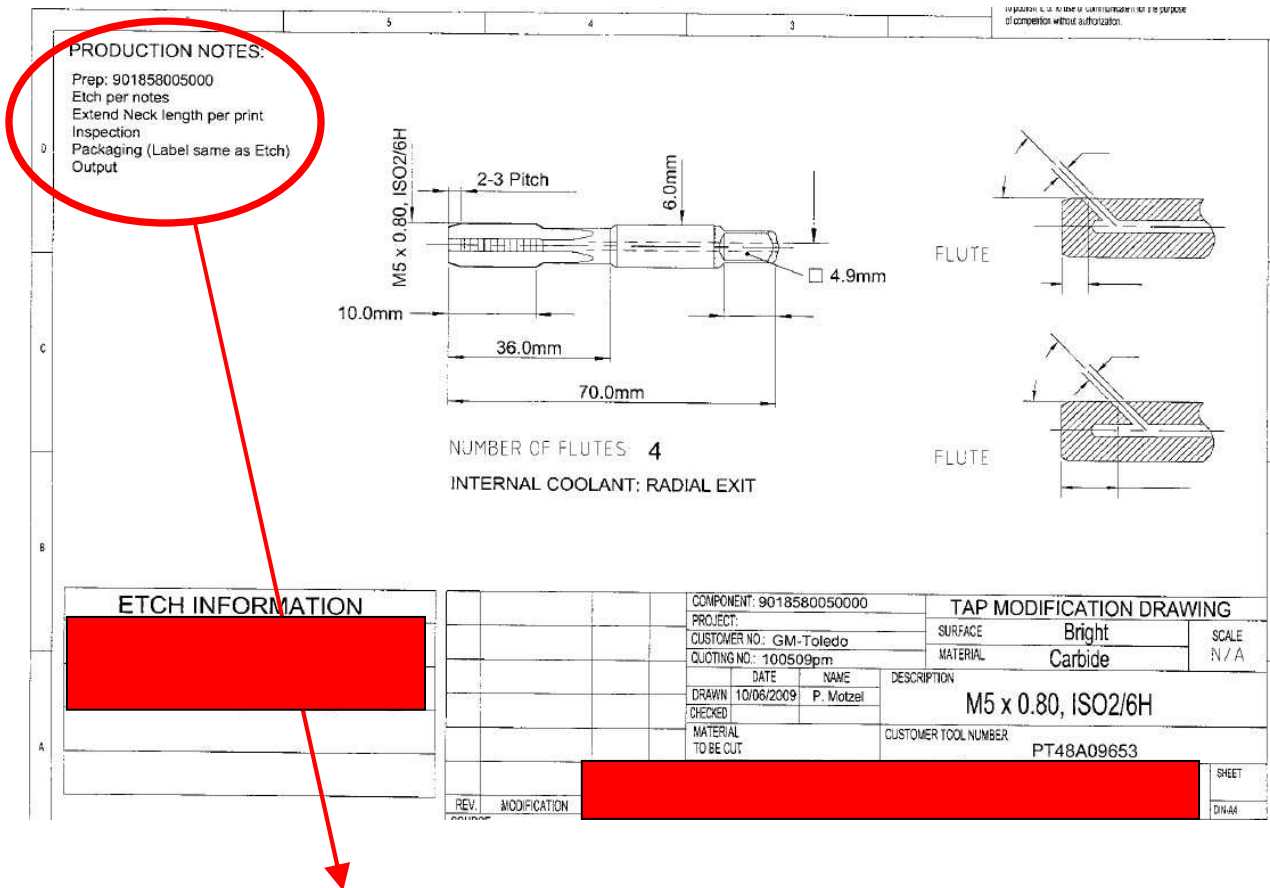
Figure 2. Tool drawing

Extend Neck length per print

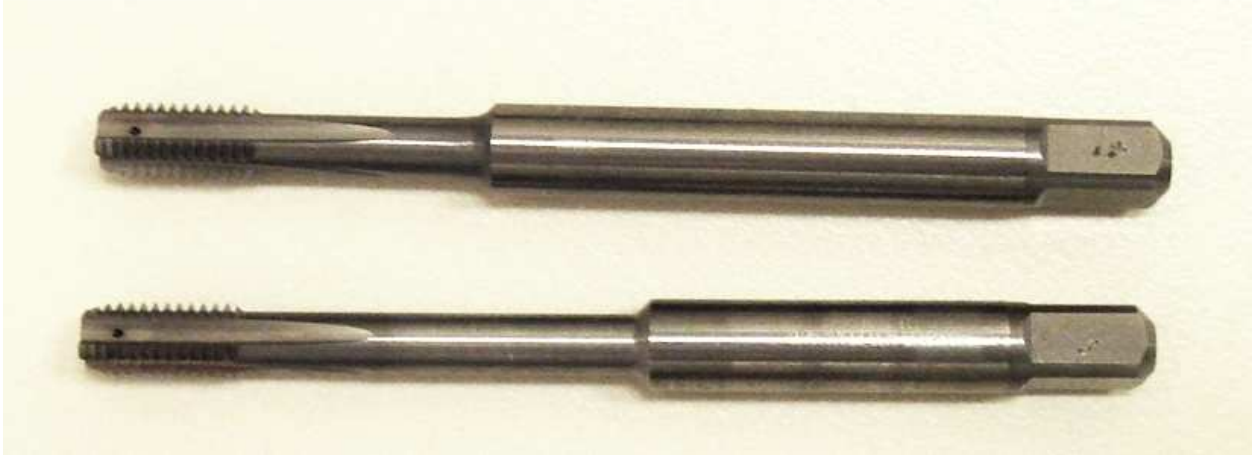
The measurement of the actual tap set for the operation showed that the neck length of this tap is 26mm. Figure 3 shows the comparison of the actual tap having neck length of 26 mm and the correct tap having neck length of 36 mm according to the drawing shown in Fig.2. Therefore, the **root cause** of the problem is insufficient neck length of the tap. In other words, the taps sent to PSMi are not according to the drawing.

**Figure 3.** The actual (above) tap having neck length of 26 mm and the correct tap (below) having neck length of 36 mm according to the drawing shown in Fig.2
