**Tooling Research and Application Department**  
**Dr. Viktor P. Astakhov**

**Tool:** Two-flute carbide drill XXXXXXXXXXXX

**Problem:** Excessive machine power

**Failure mode:** Excessive tool wear

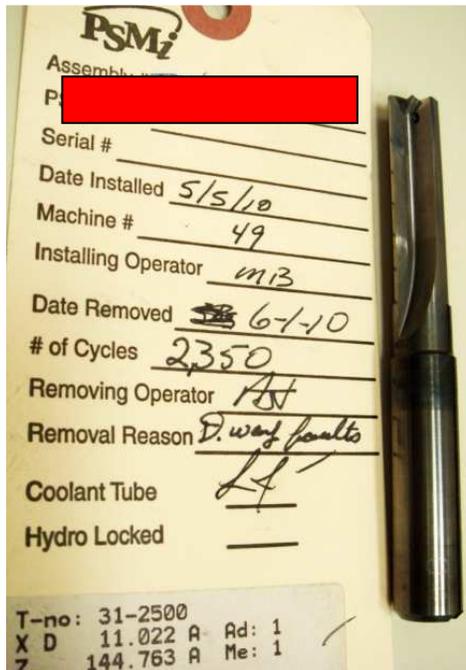
Figure 1 shows the failed tool and its tool tag. Tool is new. As can be seen, the tool made 2,350. The tool life set for this tool is 2,500 cycles, i.e., the tool almost made the tool life. Figure 2 shows the tool drawing. As can be seen, a standard brad point straight flute drill with coolant-trough holes with the outlets on the tool flank drill is shown. Unfortunately, no particularities of the tool geometry and tool material are indicated on the drawing.

**Figure 1.** Failed tool and its tool tag

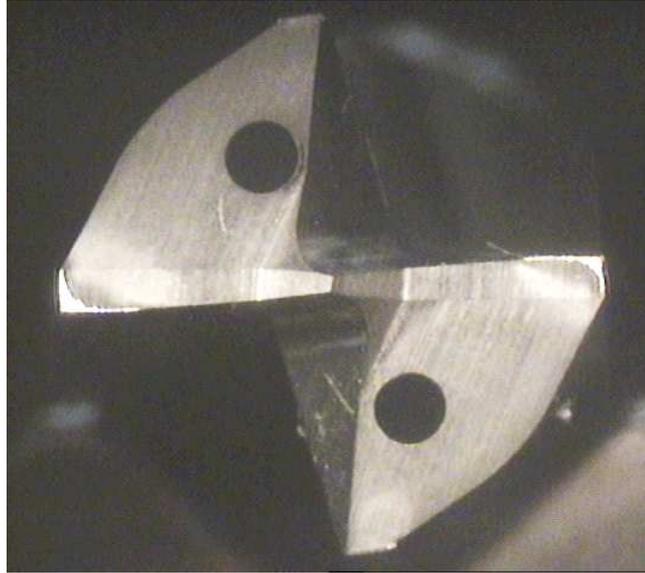
Figure 3 shows the wear pattern. As can be seen the corners of the drill failed (Figure 4). However, although the tool made 2,350 cycles which stands for 4,700 holes, no visible wear marks and built-up edge are observed on the rest of the drill. The first thought is that XXXXX found some good tool material (carbide grade) that performs very well. Therefore, the cooling and lubricating conditions at drill corners should be improved to make this tool better. Moreover, such a carbide grade should be used for all other carbide drills.

**Figure 3.** Worn drill

1. Redesign the tool making it as a four-flute PCD reamer
2. Increase the feed rate correspondingly
3. Install the tool into the machine and forget about it for a few years.

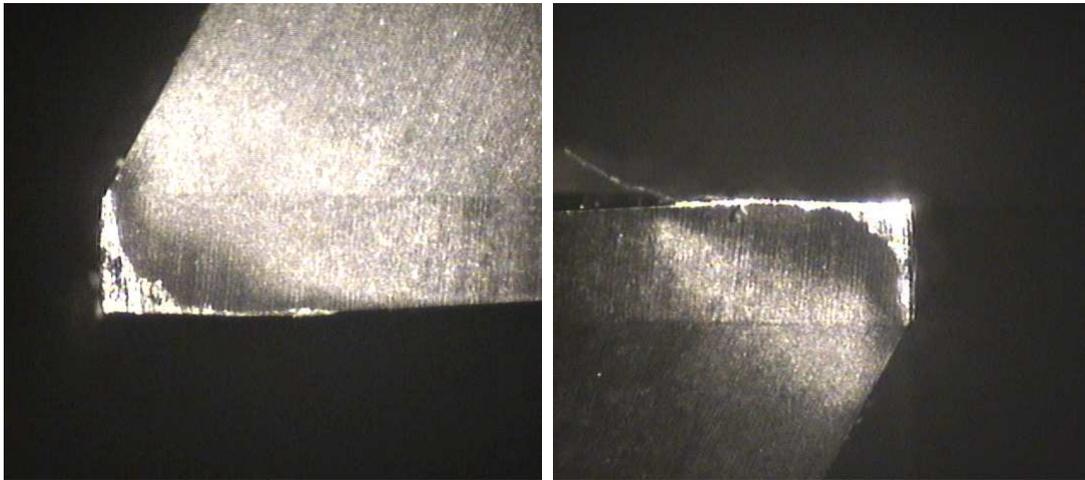
The measuring of the chisel edge angle shown in Fig. 5 indicates that this angle is almost  $80^\circ$  so that the normal flank (clearance) angle applied to the major cutting edges (lips) is nearly  $3^\circ$  which is not nearly enough for high-penetration rate drilling. As a result, severe rubbing at the drill corners took place that resulted at high temperature (see temperature profiles as black discolorations in Fig.4), and thus tool failure.

**Figure 4.** Wear pattern

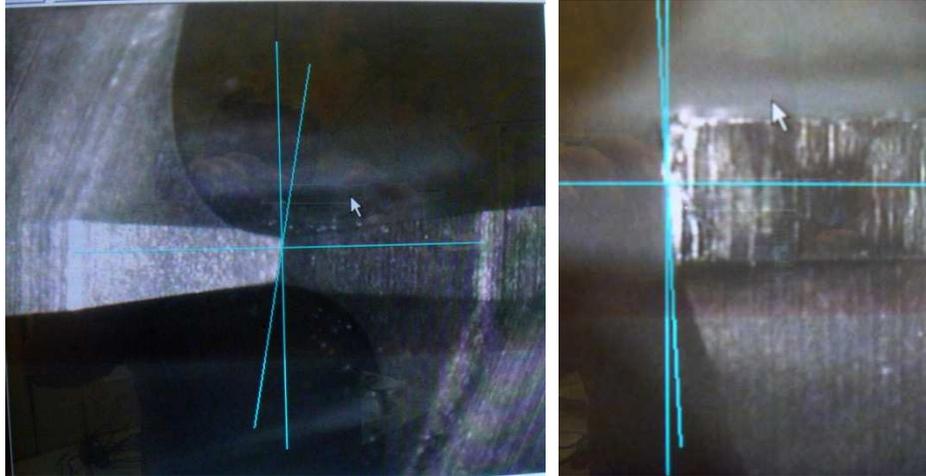
**Figure 5.** Chisel edge angle and small flank (relief) angle of the major cutting edge

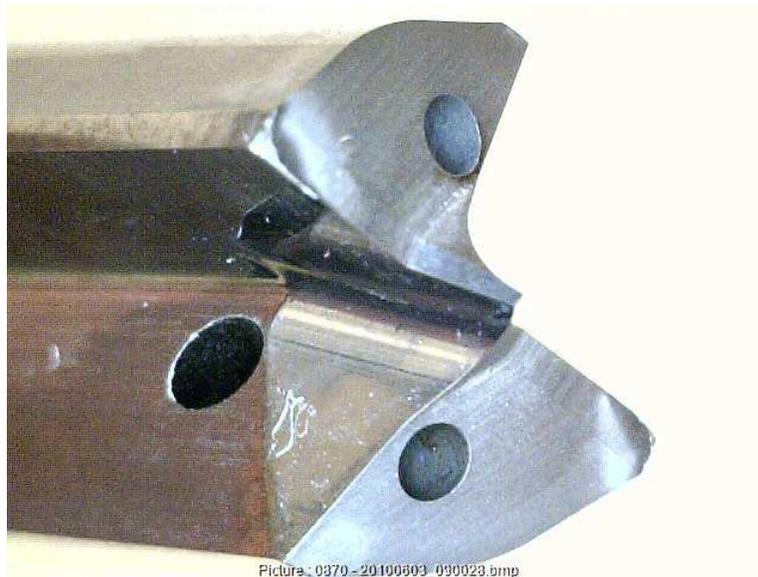
However, the first impression about the good carbide grade used for the tool was deceiving. Although **we do not have tool layouts for TCH**, it was decided to complete the analysis by analyzing what this tool is actually does in the shop floor. This results in a number of surprising discoveries. First, it was found that this tool is used for TCHs for high-feature V6 transmissions. As such, it BORES two short through cored holes removing about 1.3-2 mm per side. It explains why the central part of the tool does not have any wear marks – **it simply NEVER touches the work material**. As the holes are cored and trough, the coolant holes outlets as shown in Fig. 2, are of no use as the coolant goes through the hole and has no chance to reach the machining zone.

It appears that XXXXX made modification to the coolant holes – two side coolant holes were made as shown in Fig. 6. However, as the outlets of the coolant holes on the tool flanks were not plugged, these additional two side coolant hole did not make any difference.

**Figure 6.** Coolant hole outlets location
