Tooling Research and Application Department
Dr. Viktor P. Astakhov

Part and Feature: XXXXXXXX XXXXXXXX

Problem: Three prematurely failed tools due to oversize.

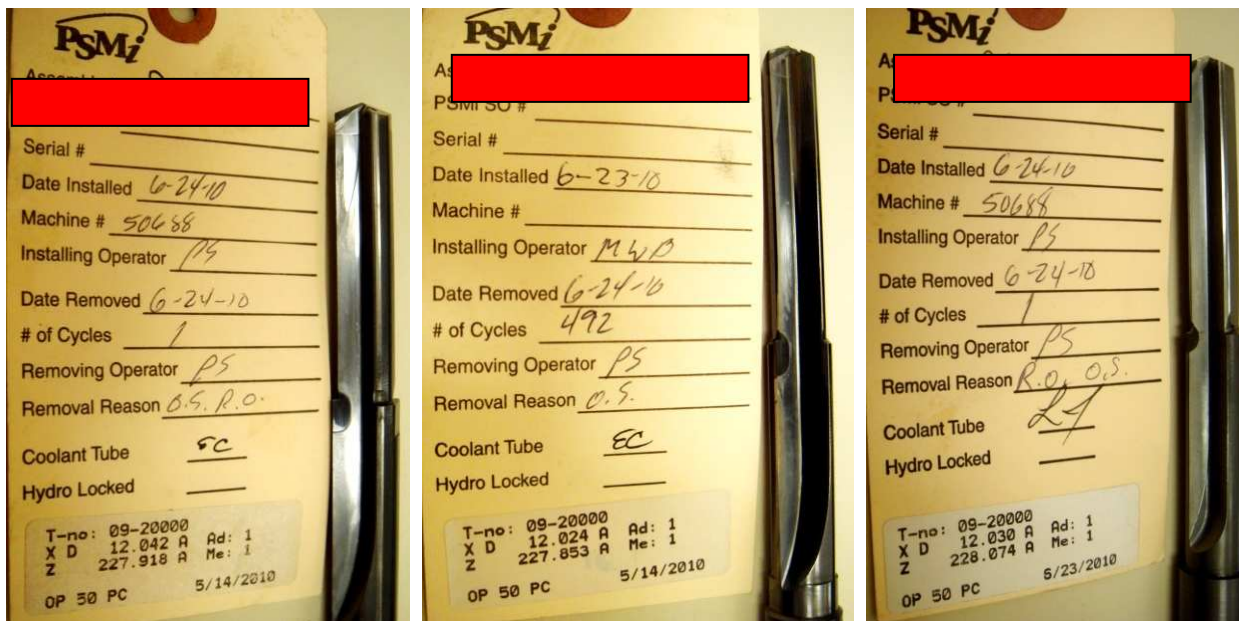
Figure 1 shown three prematurely failed tools. As can be seen, the first tool made 1 cycle, the second – 472, and the third – 1 cycle of 20,000 cycles set as tool life. Another observation can be gained from Fig. 1 – the third tool is not the same as the first two. The first two are veined drills standard for XXXXXXXX while the third tool is a PCD-tipped g-style drill. Farther investigation showed that this third drill was originally manufactured by XXXXXXXX and then re-tipped (repaired) by XXXXXXXX

Figure 1. Three prematurely failed tools

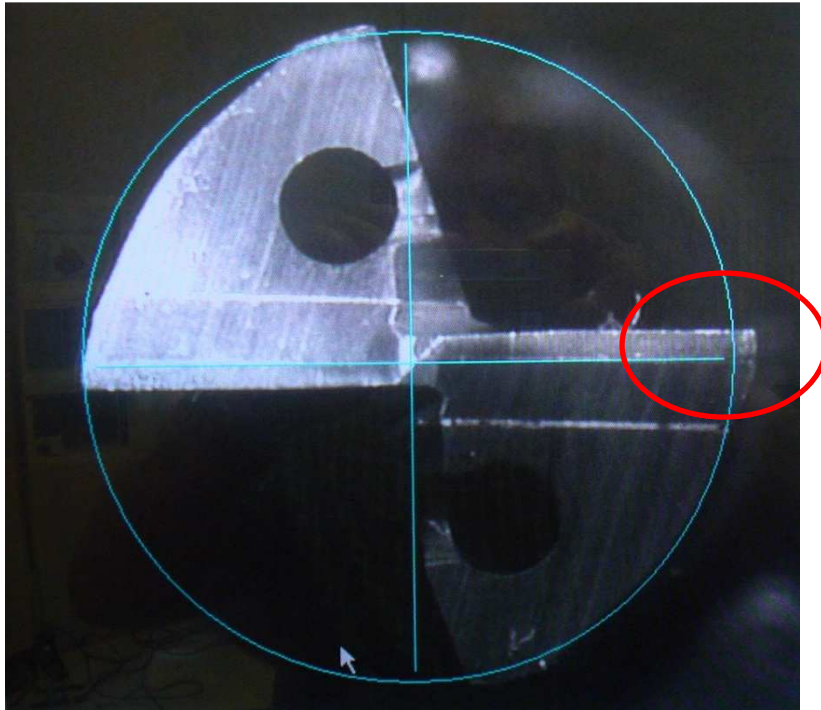
Microscopic analyses of these three tool showed that the root cause of the problem is asymmetrical location of the cutting edges and supporting parts with respect to the axis of rotation. Figure 2 shows the problem for the first drill and Fig.3 shows the issue for third drill. It

was found that the second drill has the least asymmetry which explains why it survived 472 cycles.

Figure 2. Asymmetrical grind of the first drill

1. Provide the proper tool drawing where the components of cutting tool geometry, symmetry (axial and radial runouts) of the major cutting edges, surface finish on all ground surface, coating information (composition, thickness, etc.), tool material (type, grade and make), proper dimensions including these of the chip flute and coolant holes), dimensional and shape tolerances are clearly indicated.
2. Provide the INSPECTION report with each tool where the actual values of the parameters critical to tool performance are shown.

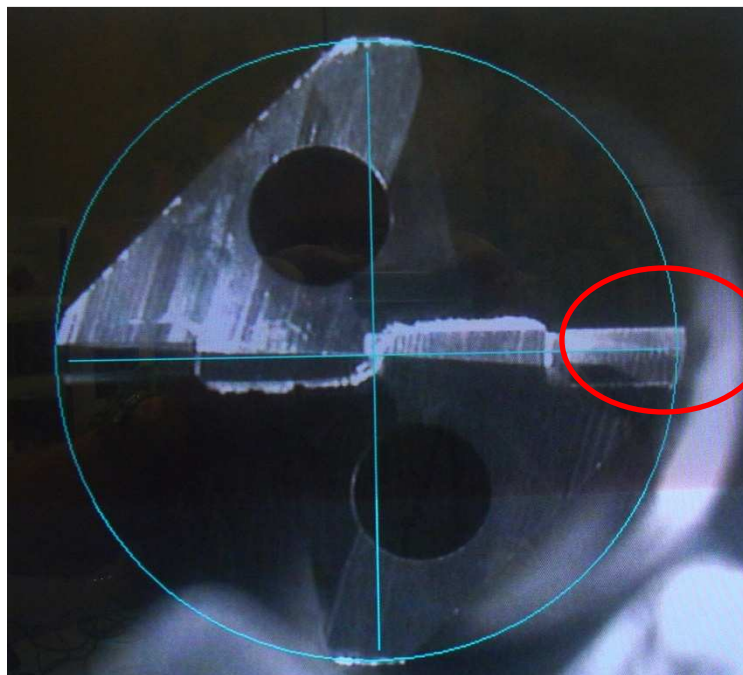
Figure 3. Asymmetrical grind of the third drill

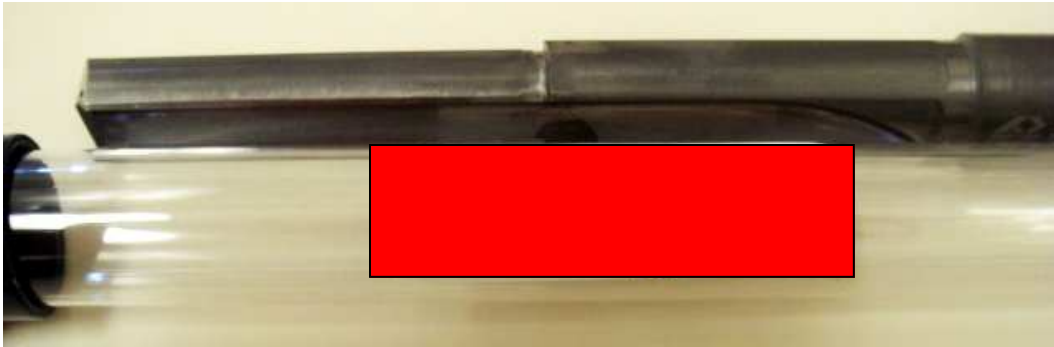
Figure 4. Drill from PSMi inventory

All the drills from a fresh supply were checked for symmetry to prevent the reoccurrence of the issue. Figure 4 shows one of the checked drills and Fig. 5 shows that it is reasonably symmetrical.

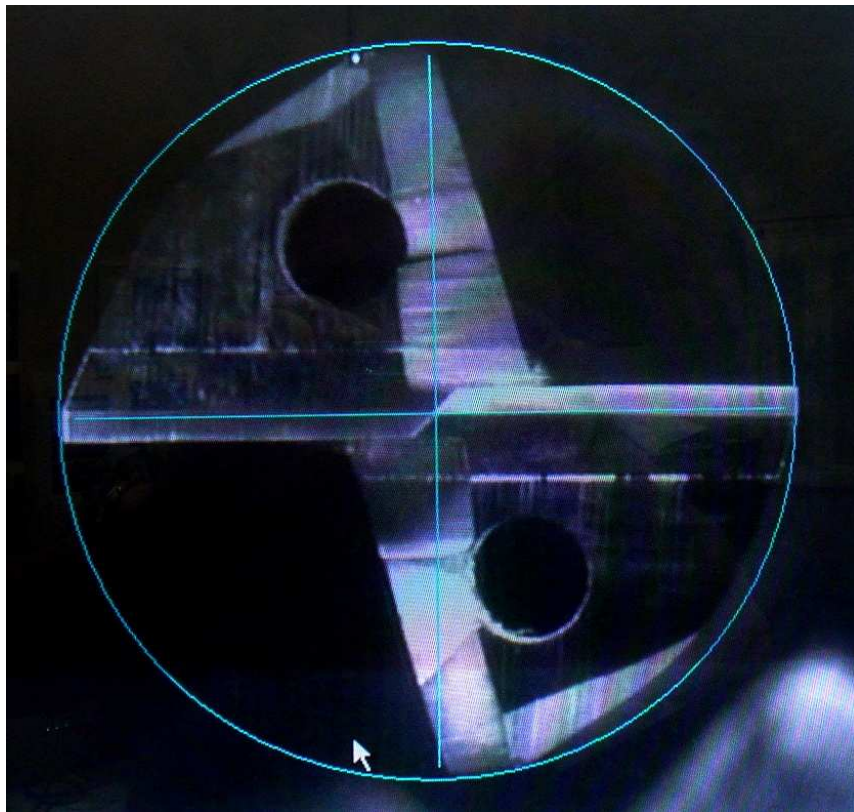
Figure 5. Symmetrical (proper) grind of the drill from PSMi inventory

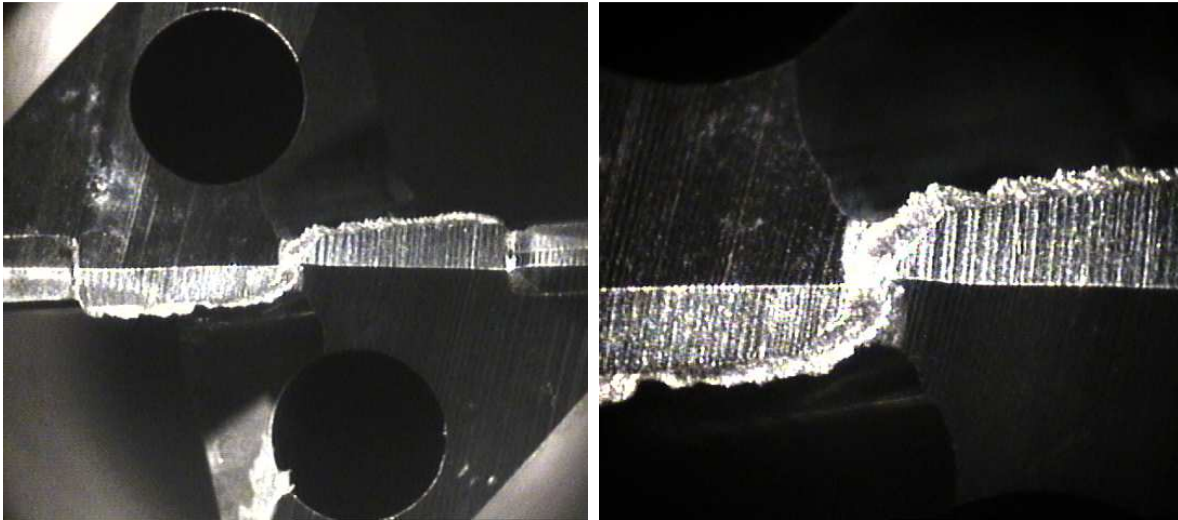
Figures 6-10 show that the third (PCD-tipped) drill was not properly manufactured. Figure 6 shows that an excessive built-up edge formed on the drill's carbide portion due to rough surface finish. Note that this drill made only ONE CYCLE. As the chisel edge of the drill is completely covered by this built-up edge, the drill lost its self-centering ability on the first cycle.

Figure 6. Excessively coarse grind of the flank (relief) faces of carbide part of the drill.

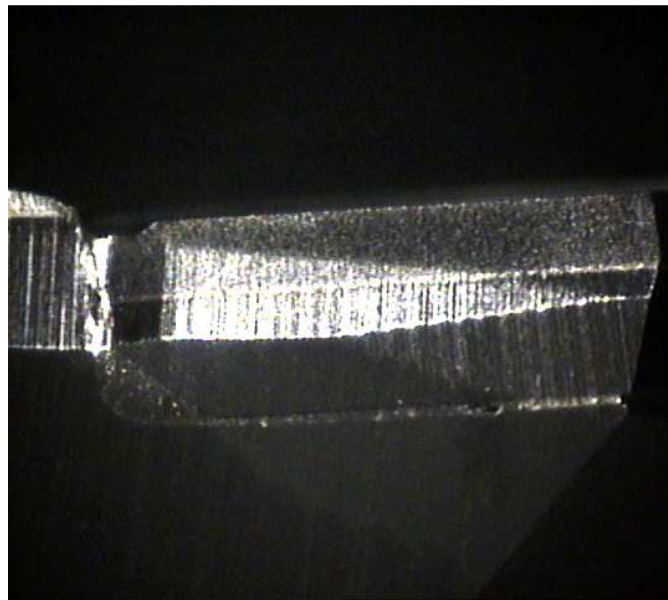
Figure 7 shows an excessive gap between the PCD insert and carbide body. On drilling, this gap is filled out by aluminum that sets drill out of the force balance, and thus cause drill wandering. Normally, there should be NO GAP and the thickness of brazing filler should not exceed 0.1mm.

Figure 7. Excessive gap between the carbide body and a PCD insert filled by aluminum

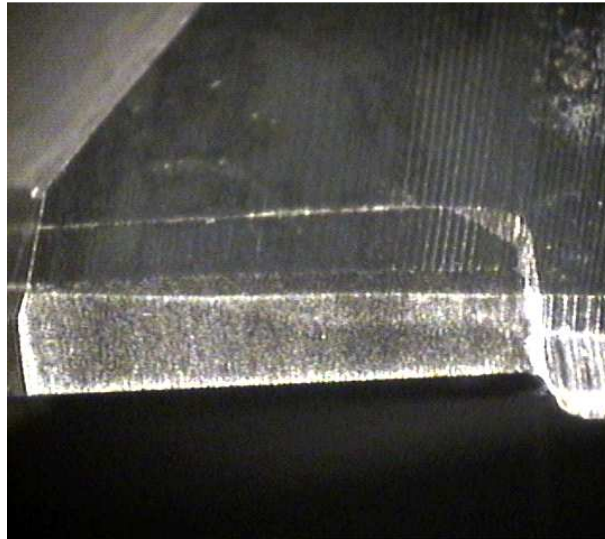
Figure 8 shows that PCD insert is not aligned with the rake face of the flute that adds additional cutting forces and causes chip accumulation.

Figure 8. Step on the tool rake face as the PCD insert is not aligned with the rake face of the flute

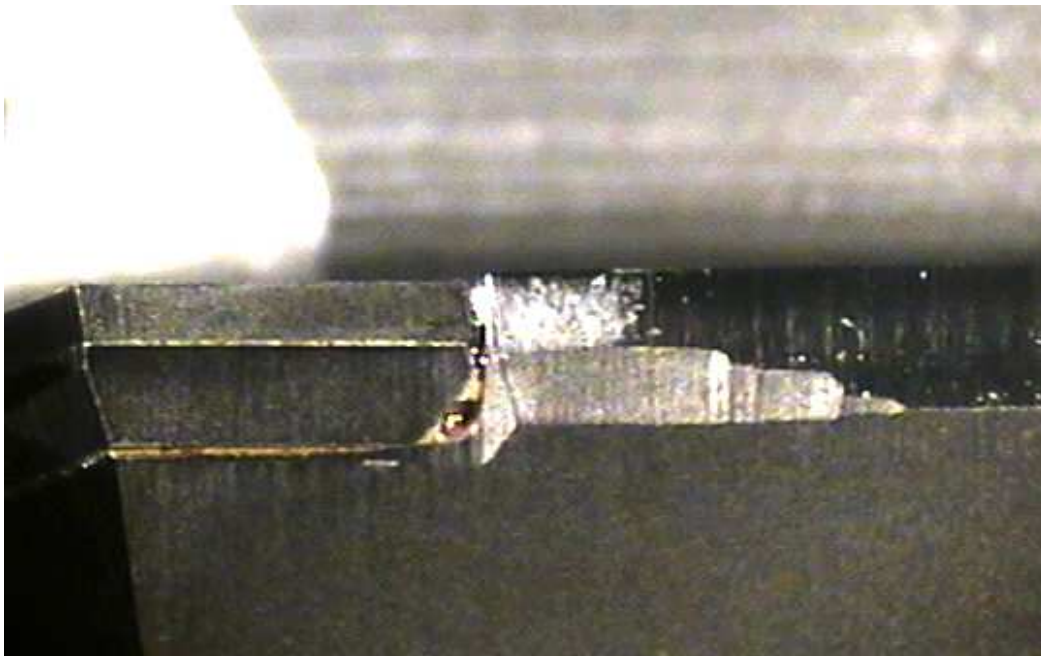
Figures 9 and 10 show inferior brazing of the PCD inserts into the carbide body with voids and gaps. The lack of backtaper and body clearance caused rubbing of the body margins that ruined the surface finish of the machined holes.

Figure 9. Inferior brazing with voids and rubbing marks on the margin of the carbide body due to lack of backtaper and body clearance (the first PCD insert)

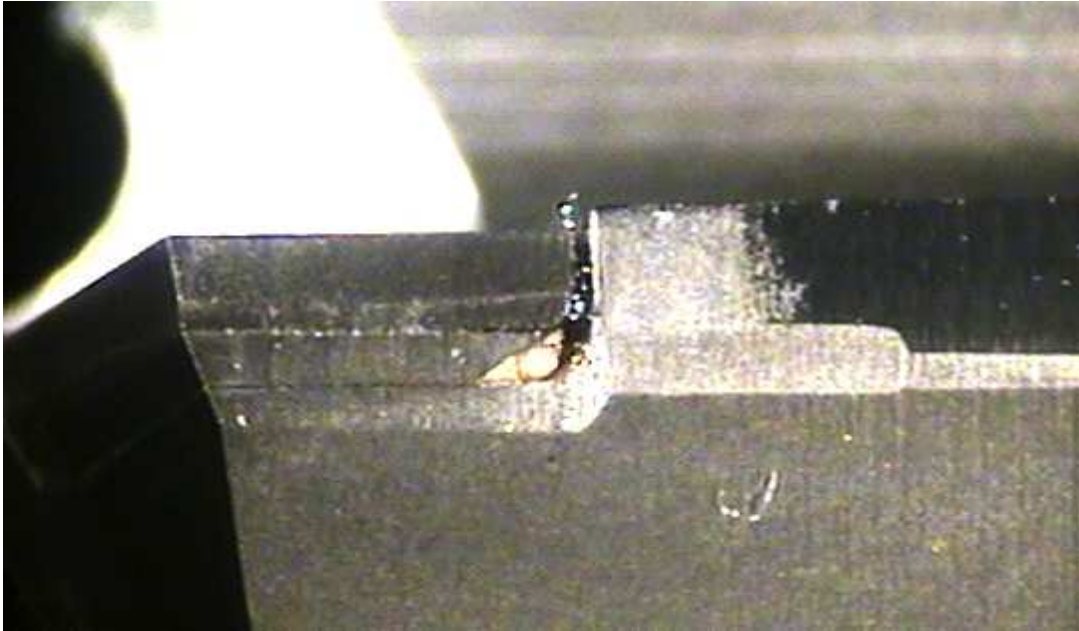
Figure 10. Inferior brazing with excessive gap between the PCD inserts and the carbide body. The edge of the body served as an additional cutting edge that cut microchips. Rubbing marks on the margin of the carbide body due to lack of backtaper and body clearance (the second PCD insert)

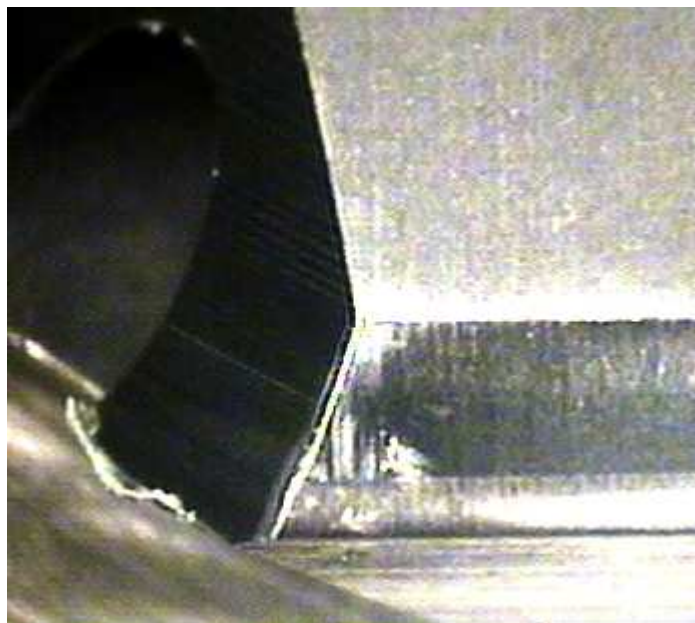
Figure 11 shows aluminum deposit or built-up edge on the supporting pad due to drill's asymmetry as drill was wandering on the hole being drilled due to asymmetry and violation of its force balance.

Figure 11. Aluminum built-up edge on the supporting pad due to drill's asymmetry
